SUBJECT: Animal Feeding Operation (AFO) Compliance Inspection for – 816,
County – Hardin, – Facility #64258

AFO INSPECTION REPORT

FACILITY LOCATION	Facility: 816			Facility ID#: 64258	
	Address: 18112 155th St.		City: Iowa Falls	State: IA	Zip: 50126
	PLSS: Section 33, Alden Township (T89N, R21W), Hardin County				
OWNER	Name: Woodford Creek Farms LLP				
	Address:		City:	State:	Zip:
ANIMAL HOUSING TYPE	<input checked="" type="checkbox"/> Confinement <input type="checkbox"/> Open Lot <input type="checkbox"/> Combined (Confinement & Open Lot)				
ANIMAL INFORMATION	Animal Type(s)	Capacity	Current Head	Number of Bldgs./Pens	
	Wean/Finish Swine	4160-Head	4160	2	
	Date of Construction: 2006		Date of Expansion: N/A

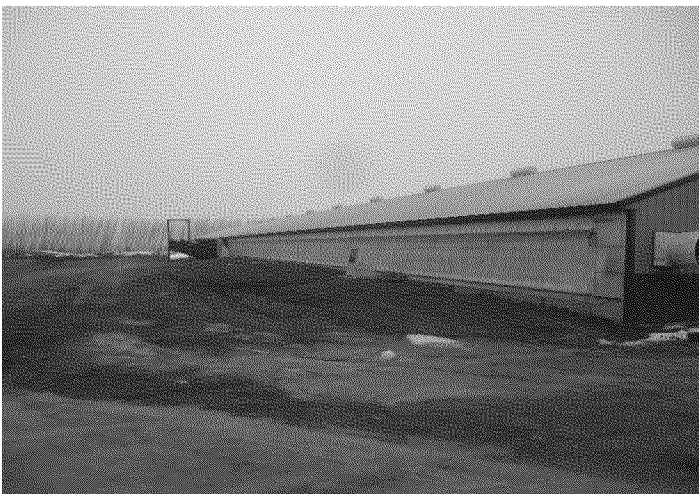
South side of north building – looking west

During the inspection, I walked the entire perimeter of both buildings. I observed that portion of the manure storage structure (pit) concrete which was visible above-ground. This amounted to approximately 2-feet of concrete, which would be above the slats covering the below-building deep pits. The observed concrete appeared to be structurally sound, as I observed no obvious evidence of cracking, excessive spalling or other issues of concern regarding the visible portion of the concrete. I did not observe any evidence of manure discharges either from or in the vicinity of the buildings.

While no evidence of discharge was observed during this inspection, it is recommended that the manure storage structures be inspected for discharges and needed repairs regularly, as confinement feeding operations must contain all manure produced between periods of application. Additionally, any future discharges may require that an NPDES permit be obtained for the operation.

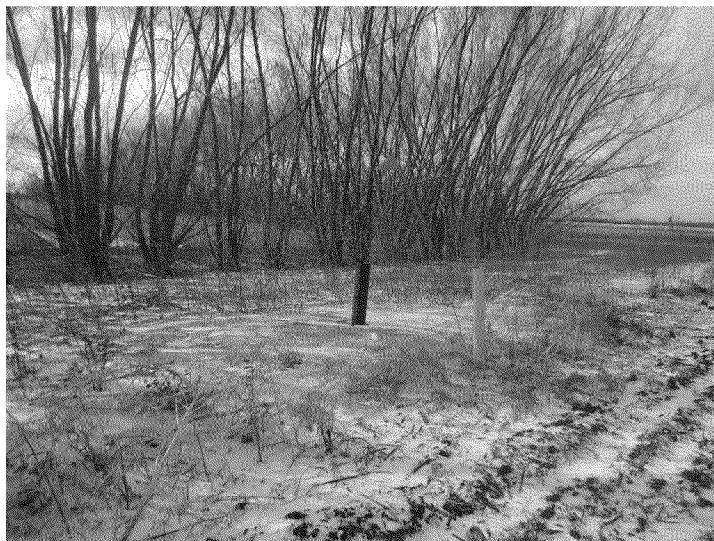
I did observe a drainage tile observation port and associated shut-off valve located approximately 100-feet due north of the north confinement building, between the facility windbreak and the adjacent crop field. I could see some water in the tile, via the observation port. I did not detect any visual, olfactory or other indication of manure contamination in the tile. The presence of these structures documents compliance with both IAC 567 65.15(14) and Construction Permit Condition Nos. 4(d) and (e).

Drainage tile observation port (black) and shut-off (green)

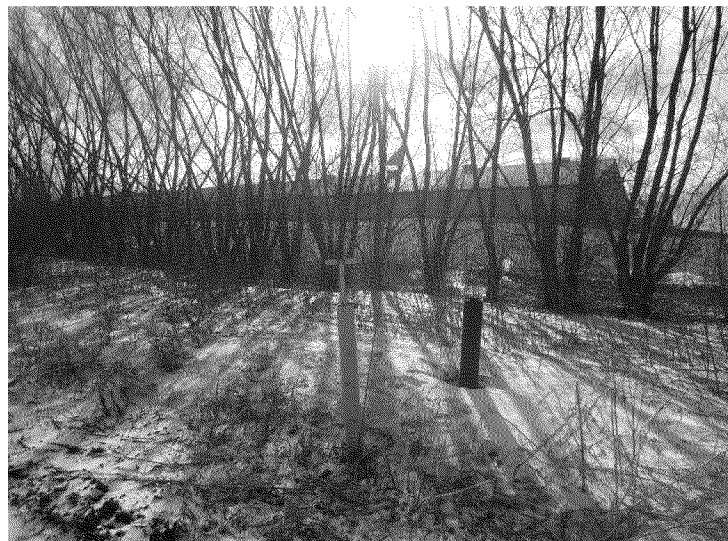
Same – looking southeast toward north building

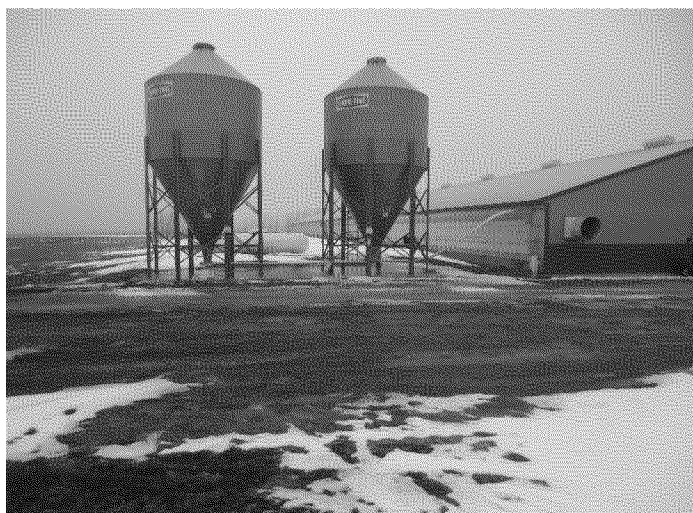
During the inspection, I observed the bulk bin feed system serving each building. All bins, feed conveyance pipes and various attachments appeared to be intact and effectively containing feed. This part of the operation should be inspected frequently, as runoff water could carry spilled feed into a water course where it could create violations of state water quality standards. Discharge of such process water would potentially require an NPDES permit.

South building feed bins and piping

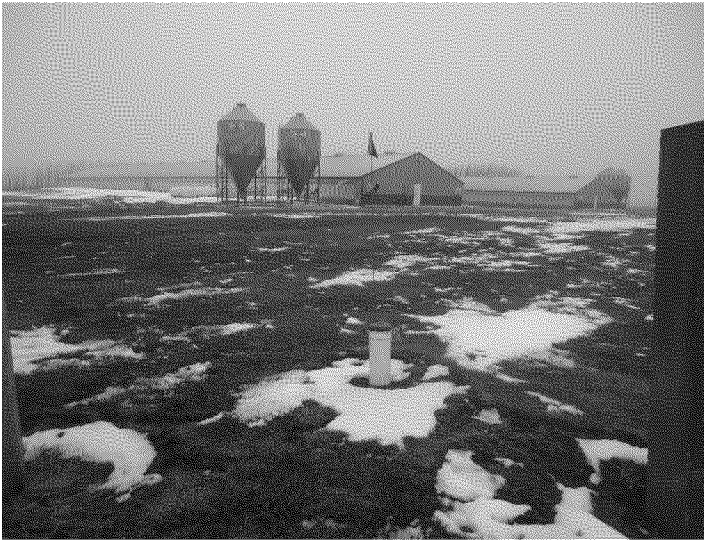
The water well serving this facility is located up-gradient and approximately 140-feet to the southeast of the southeast corner of the south confinement building. The combination of distance and elevated position, in relation to the buildings, provides excellent protection of the well from possible contamination due to any discharge(s) of manure or contaminated process water.

Looking northwest from well to buildings

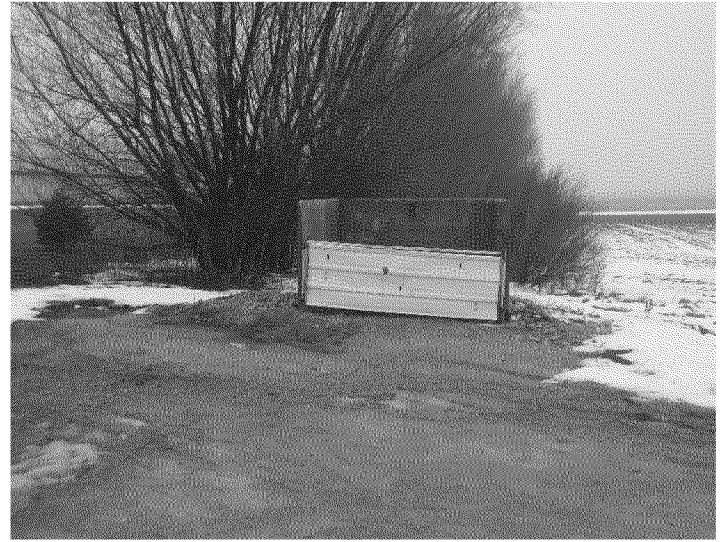
Currently, carcasses are collected on-site for rendering. There is a carcass collection enclosure (dead box) located to the north of the facility on the east side of the gravel drive. The dead box structure is located on packed gravel and the surrounding area is both flat and vegetated. I did not observe any tile intakes in the immediate vicinity of the dead box; and

I did not observe obvious evidence of contaminated runoff from the dead box or immediate area. Therefore, the dead box appears to be sited in a location with little potential to cause contaminated surface runoff to leave the facility.

Dead box enclosure on north side of facility
